Home Inspection Report

Conducted on: 1/29/2016 from 9:00AM to 6:30PM

Jen and Pete Smith
562 Main Street
Hendsonville, NC 28789

NC Licensed Home Inspector:
Rand Soellner, Lic.# 3112

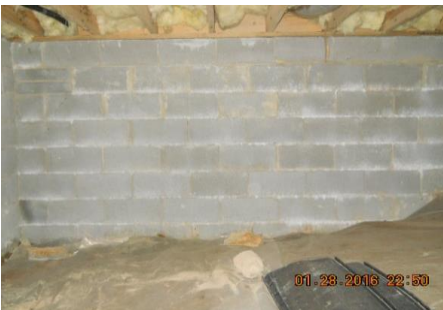
R/R 1.1 FOUNDATION : CONCRETE BLOCK HAS NO EXTERIOR WATER-RESISTIVE COATING

The wall is concrete block, and concrete is a porous material. You have to coat it with special exterior water-resistive paint (such as elastomeric) to be able to inhibit the entry of water into wall. It is assumed there is no coating (or it has failed) due to discoloration.

ALL exterior CMU (Concrete Masonry Units: "Concrete Block" should be sealed, where there is interior space on the other side of the wall. This sealing may be in the form of below-ground water proofing, or above ground, in the form of special water-resistive paints & coatings. However, the chalking at the joint lines is evidence of moisture leaking through.

Repair/Replace Recommend having State licensed Caulking/Coating contractor inspect and coordinate corrective repair & replace actions with a State licensed General Contractor.

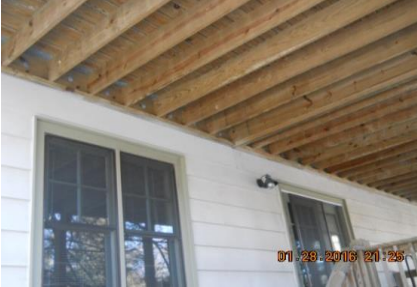
This might be dangerous, if not repaired. This braces the porch deck structure against high mountain winds and seismic movement. It is a common practice, in the western North Carolina mountains, to install a flatways p.t. 2x4 or 2x6, each attached to each deck joist, with the brace at about a 45* angle in plan view. The idea is to link together all the deck joists and the post tops in high mountain winds, to engage the entire structure to resist imposed horizontal movement.

Investigate/Repair/Replace Recommend having licensed Structural Engineer examine this and see if this would be prudent to add. Then have licensed Contractor install, if required.

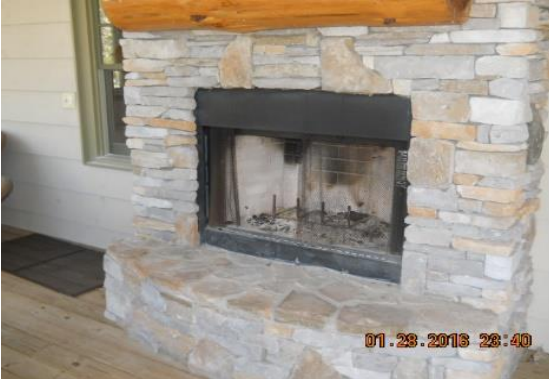
In recent years artificial stone has been used with increased frequency on the exteriors of buildings. In many cases the installation has been found to be improper and not in compliance with the installation instructions of the stone manufacturers. Incorrect installation can result in water penetration, structural damage, and mold growth. The following language is recommended for use by home inspectors (by the NCHILB) with regard to incorrectly installed artificial stone siding.

Weep screeds are missing at the base of the wood frame walls. (this is usually a plastic perforated strip at the bottom of stone veneer that allows any water penetrating the veneer to drain out at the bottom, which means that having nowhere else to go, any moisture in the wall could leak into the interior, into structural locations which can cause rot, and can assist mold growth inside the wall cavity).

Weep screeds are missing at the tops of window and door openings.

Flashings are missing where roof eaves meet the masonry veneer.

Therefore: it is recommended that the homeowner contact the manufacturer of the artificial stone veneer siding and ask them for a technical evaluation and recommendation as what should be done, if anything.

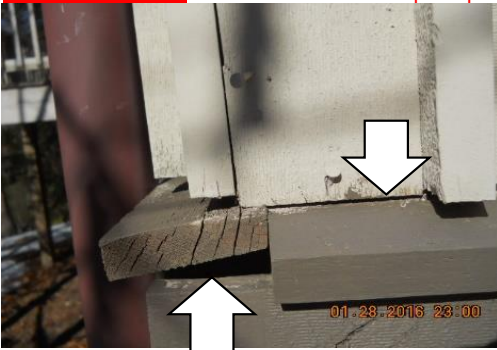
no horizontal "Z" flashing at horizontal changes in wall trim/material. Corners and edges like these are exposed around the house.

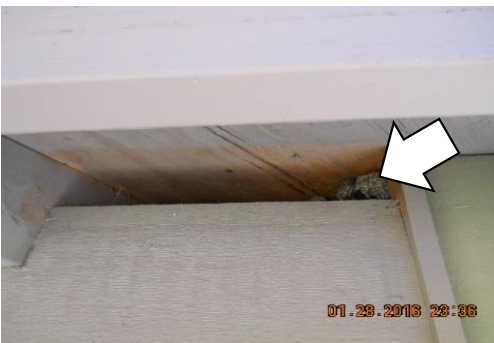
Substantial gaps near upper exterior wall around the back of house, main level as viewed from deck. Wasp nest visible.

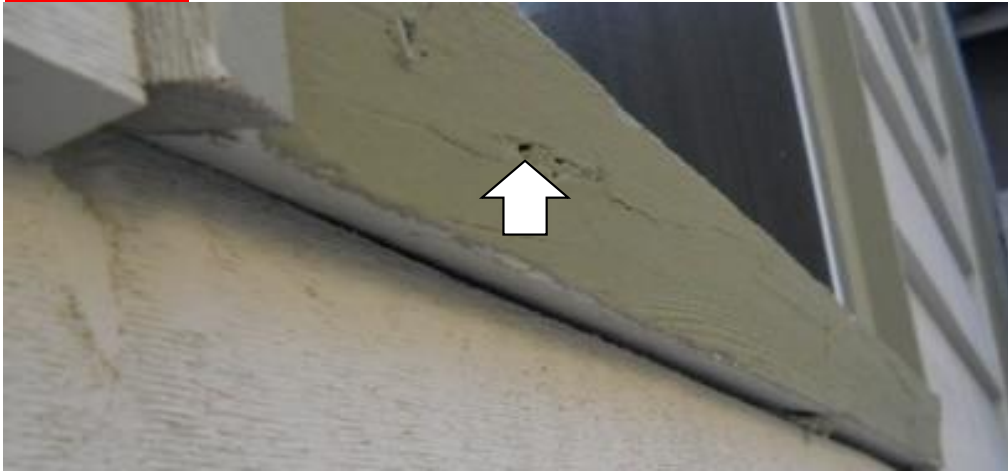
Window sills, in particular, appear to be wearing, with separations of material and pits, through which water, snow and ice can enter. Even though it is obvious that some recent paint has attempted to fill in these gaps.

Recommend having licensed Contractor repair/replace with pressure treated wood or cement siding products.

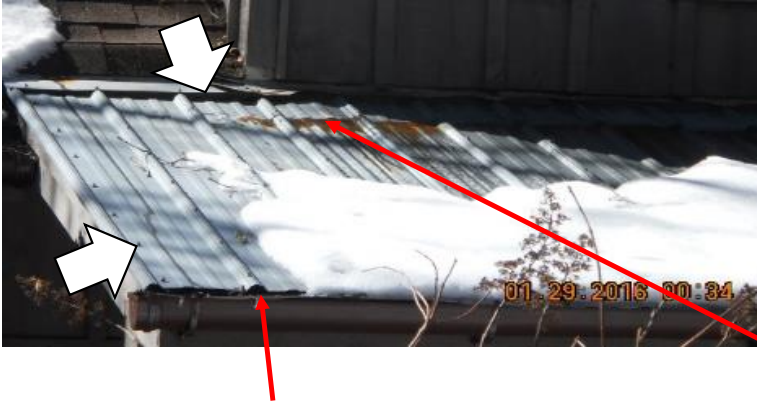
Also: we didn't notice end inserts into the raised metal flutes between panels. This means that wind blown rain and insects can get into these joints. We also didn't see edge drip flashings around this roof.

Unfortunately: the fasteners were not installed along the high points at the ribs, but instead were installed along the lower places (where the water runs), greatly increasing the chances of a future fastener leak.

Investigate/ Watch/Warning Suggest monitoring for signs of leaking over time. If leaking is noticed, then: Recommend eventually having a state licensed roofer tear off existing roof and any underlayment waterproofing membrane then reinstall type of metal roof with concealed clip system with No exposed fasteners.

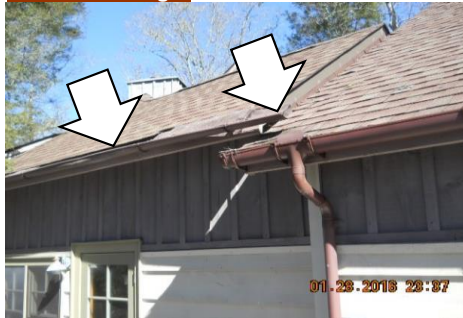
Debris and snow and ice has moved the gutter guard off the building in several places.

Investigate/ Watch/Warning Recommend having an experienced licensed tradesperson/company remove debris.

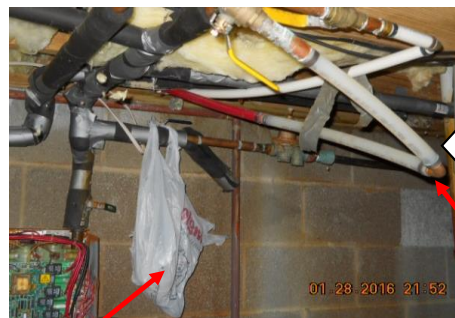
Bag of parts

Confusing piping of various colors above old tankless HWH, hanging bag of parts, streaks of probable leaks on wall.

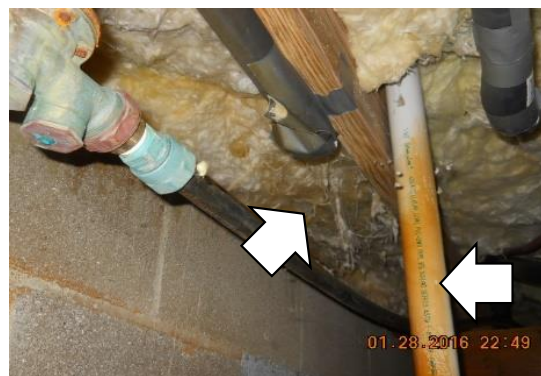
There is very damp earth in a footing trench under this wall: that moisture could be from the outside world and/or a leak coming from this piping above.

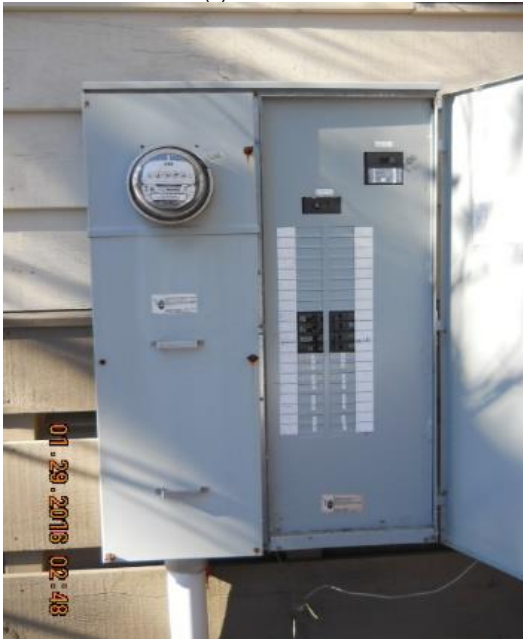
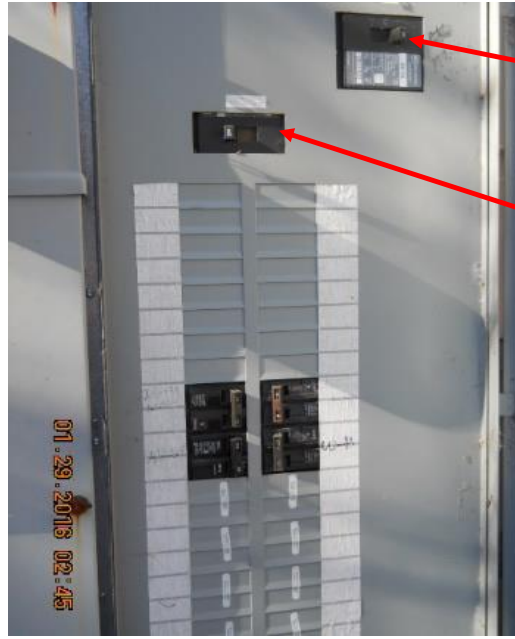
PHOTO(S) OF MAIN PANEL:

appears to be 150a breaker for subpanel in house.

appears to be main 200a breaker.

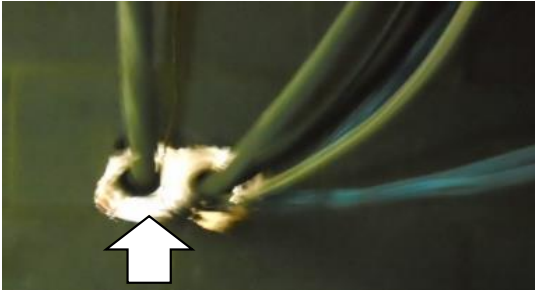
In the crawlspace, you can see daylight to where we believe the power cables are coming into it from behind the MDP on the outside left wall.

The fact that we can see daylight around these main electrical power cables coming through the interior crawlspace foundation wall tell us that there cannot be any sealant (or not enough) protecting the annular space around these cables and the CMU (Concrete Masonry Unit = "block") wall.

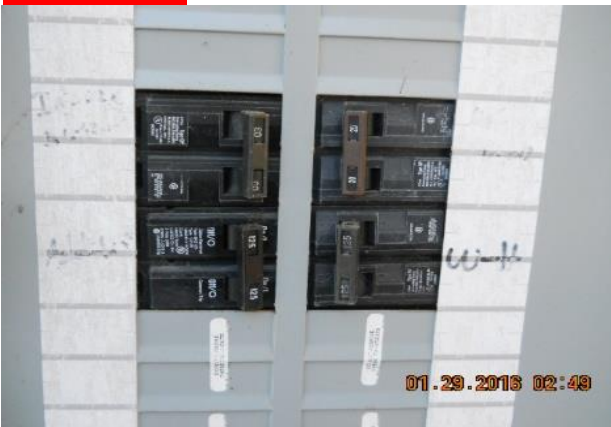
These breaker labels at the MDP are illegible.

Have circuits identified and professionally labeled in a permanent manner by a State-licensed electrician.

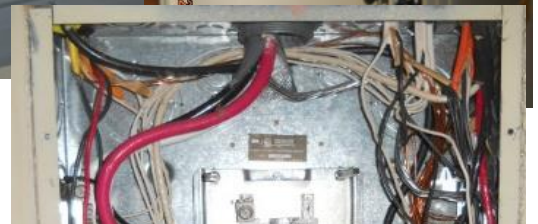
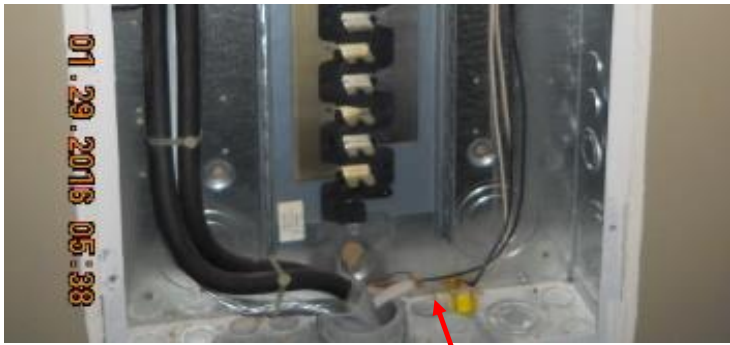
There are multiple strikeouts in this panel

that make it hard to understand what's what. The breakers should be reidentified professionally.

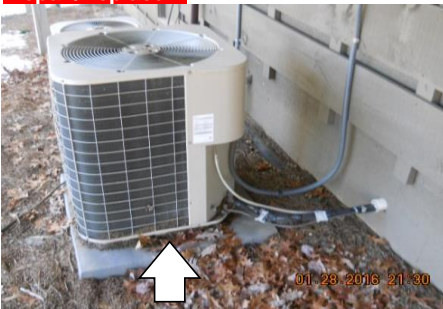
In this case, this is actually nothing significant, but the bottom of these units should be kept clean and clear.

Service &/or Repair/Replace Recommend having this checked by a State licensed mechanical contractor, cleaned, repaired and serviced.

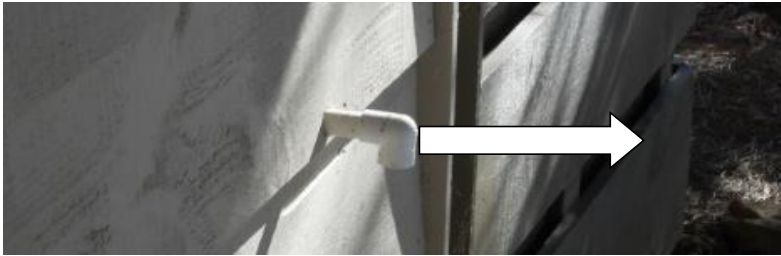
Also: keep in mind that we do Not know where the condensate drains from the main crawlspace AHU.

Repair/Replace Recommend having State licensed contractor specializing in Plumbing & Mechanical work to inspect, repair and extend drainline away from home and foundation vicinity as required.

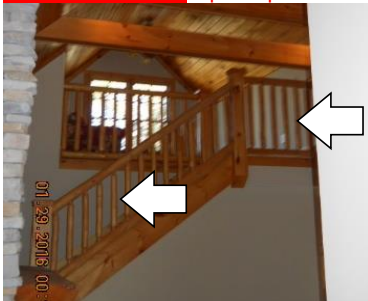
R/R 8.4.2 INTERIOR STAIRS: SPACING BETWEEN PICKETS IN GUARDRAIL TOO WIDE.

Dimension between pickets is larger than 3-7/8".

Repair/Replace Recommend having State licensed Architect prepare corrective detail, then have State licensed General Contractor repair or replace per Architect's detail.

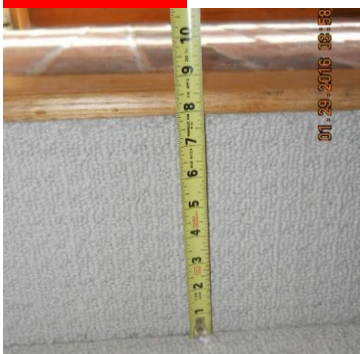
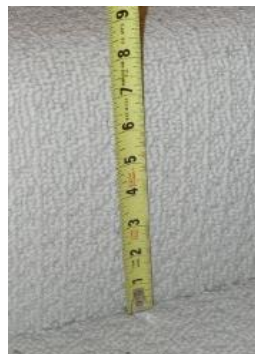
Also: winder stairs these days functionally need to have a minimum tread depth of 4". These winder treads go to 0". The implication is that your foot can fall more than 1 riser if you get too close to the interior side of the steps.

Repair/Replace Recommend having State licensed General Contractor investigate, determine corrective action, the suggest repair or replace.

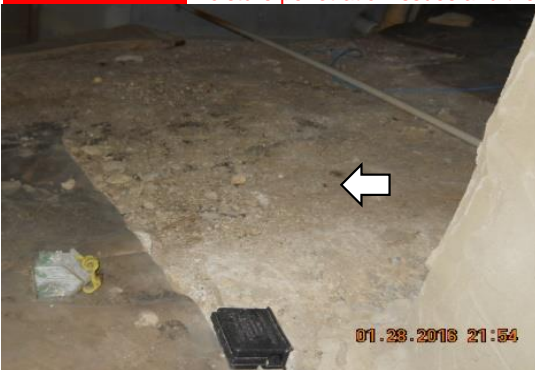
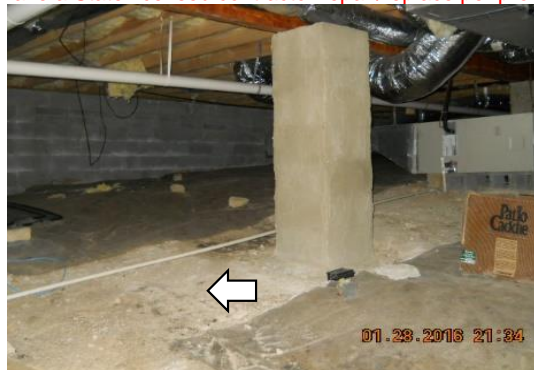
Exposed gravel/dirt in most areas.

Repair/Replace Recommend having State licensed Architect prepare a Comprehensive Rainwater Management Plan (CRIMP) to correct moisture penetration issues and then have a State-licensed contractor repair/replace per professional documents.
