Home Inspection Report

Conducted on: 1/29/2016 from 9:00AM to 6:30PM

Jen and Pete Smith
562 Main Street
Hendsonville, NC 28789

NC Licensed Home Inspector:
Rand Soellner, Lic.# 3112

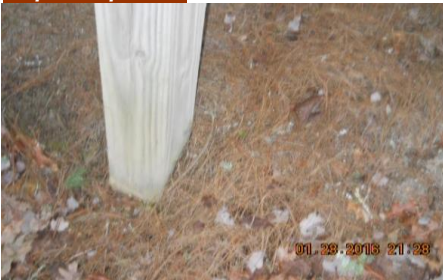
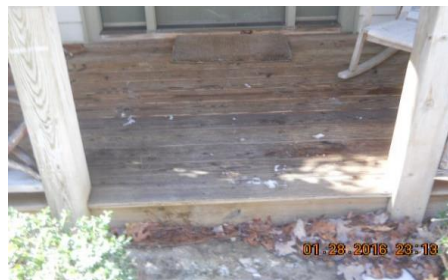
Posts DO appear to be pressure-treated (green tint color noticed but no legible P.T. certification stamps were seen as being suitable for Ground Contact). If this wood is not For Ground Contact, it can be susceptible to wood destroying organisms, especially when contacting the ground. Termites, carpenter ants and other organisms can eat the wood, making it unstable, causing eventual structural collapse. However, these posts Might be For Ground Contact. No softness was noticed and they have been here on the main house for 17 years and the addition for 11 years. It is common practice in this area of NC that For Ground Contact wooden posts are used to allow for easier (and less costly) post to foundation connections.

Watch/Warning possible Recommend monitoring for any softness periodically and contacting a State Licensed Contractor at the first sign of any problems.
Repair/Replace

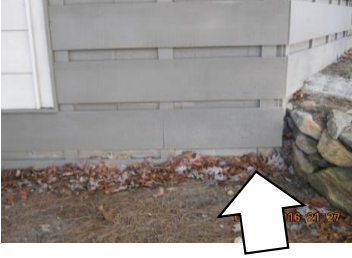
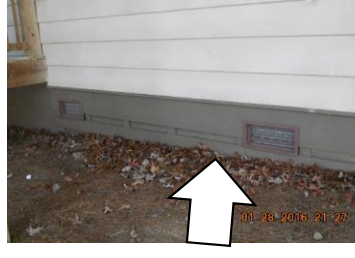
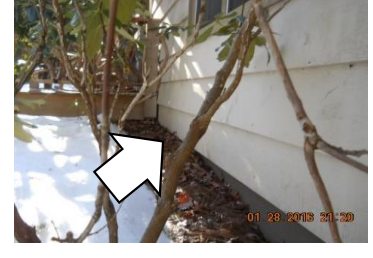
R/R 2.1.1 WALL CLADDING: PROBLEM: LOOSE WALL CLADDING MATERIALS

Location: This is mainly a duplicate of the item above illustrating the wall materials twisting and falling off the tall wood left side wall.

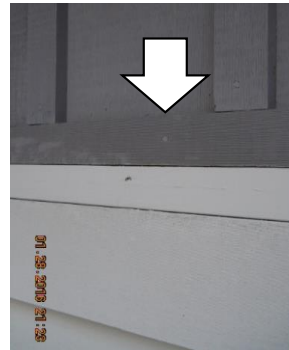
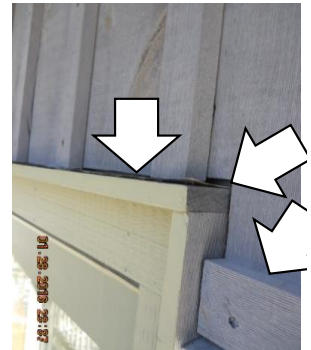
no horizontal "Z" flashing at horizontal changes in wall trim/material. Corners and edges like these are exposed around the house.

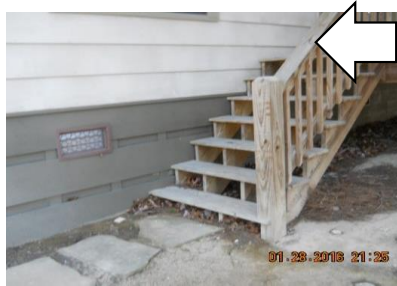
R/R 2.4 RAILINGS ARE TOO WEAK.

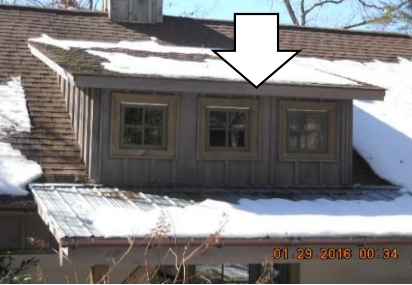
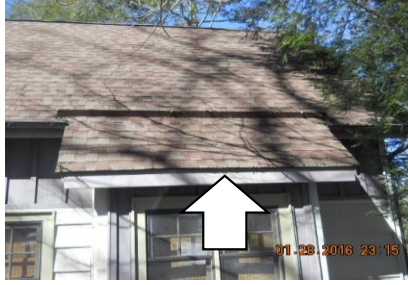
GC 3.2 SOME GUTTER GUARD PROTECTION FOR GUTTERS MISSING OR PUSHED OFF

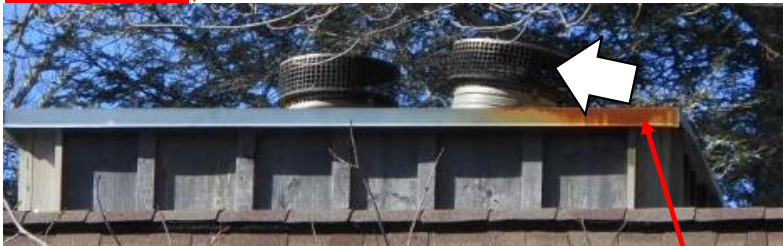
Inv 3.4 Suspect LACK OF CRICKET BEHIND CHIMNEY AT ROOF SLOPE

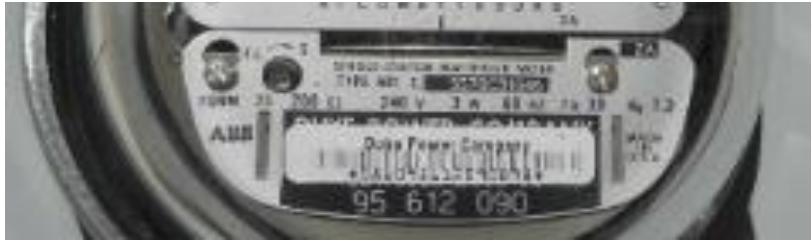
Inv 5.2.1 ALUMINUM CONDUCTORS PRESENT: SHOULD BE CHECKED & TIGHTENED:

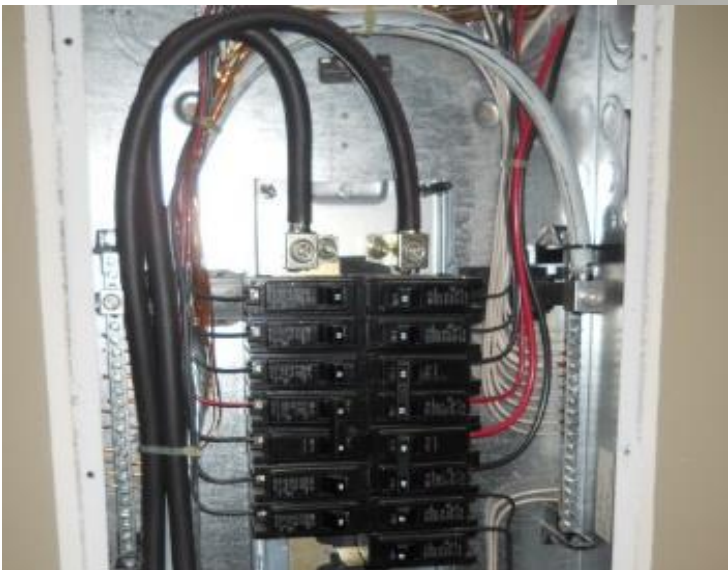
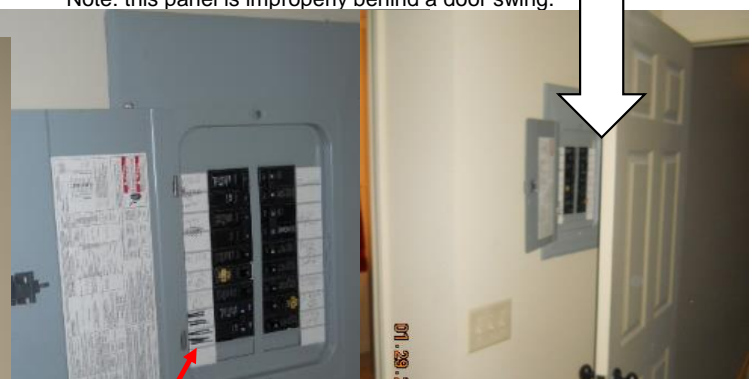
Location: Basement addition bedroom by Basement stair.

Note: this panel is improperly behind a door swing.

There are multiple strikeouts in this panel

that make it hard to understand what's what. The breakers should be reidentified professionally.

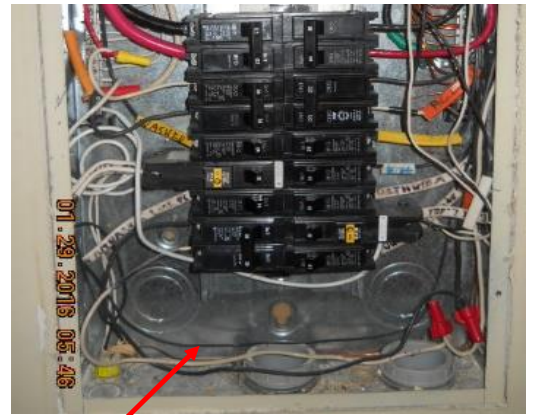
R/R 5.2.4 SUBPANEL: NO SINGLE MAIN BREAKER and more than 6 moves to turn off all.

Location: None of the subpanels appears to have a single main breaker to allow it to be turned off at once. Conditions and regulations may have been different when this home was built and this home is 'grandfathered-in' as is and nothing needs to be done. However, in the interests of safety and today's best practices & safety, it would be better if there was a single large breaker that could shut down this subpanel at this subpanel. Implications: safety: there could be an electrical emergency requiring swift action and it will take longer to turn off all the power.

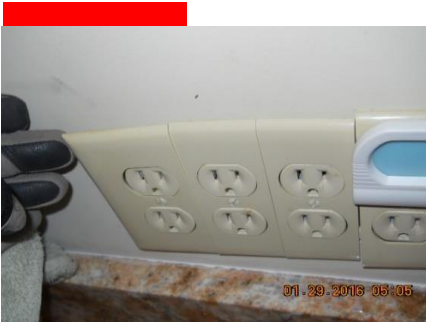
R/R 5.5.3 NO COVER PLATE RECEPTACLES IN SOME LOCATIONS:

Location(s): BR1 Left front side of house: behind head of beds on wall.

Repair/Replace Recommend having inspected and repaired or replaced by a State-licensed electrician.

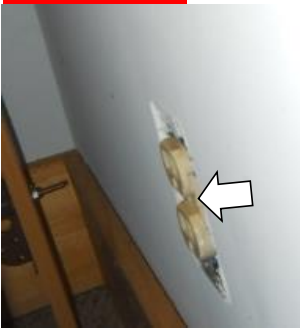
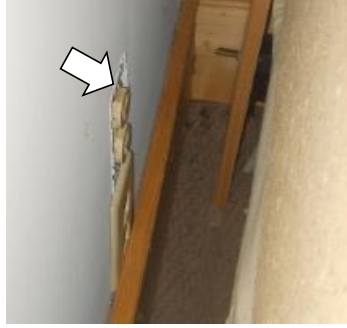
R/R 5.5.3 BROKEN RECEPTACLES IN SOME LOCATIONS:

Location(s): New addition 1st flr Bedroom outlets to sides of bed have something blocking ground socket at receptacles.

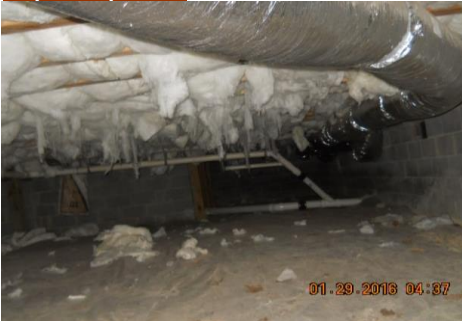
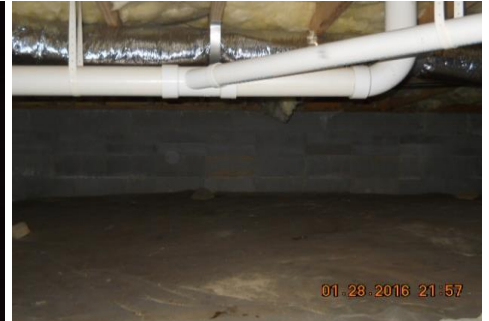
Non-functional. In crawlspace, it would be a convenience to have some working lights come on from the entry door wall switch. Perhaps they are just burned out. In any event, right now, only an open door and a flashlight will illuminate this space.

Investigate/Repair/Replace Recommend Investigation/ possible Repair/ Replacement by State licensed Electrician.

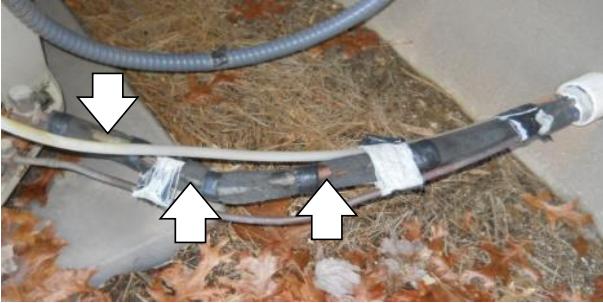
W/W 7.3.6 COOLING DIST.: NO INSULATION ON CONDENSATE DRAIN LINE FOR COOLING:

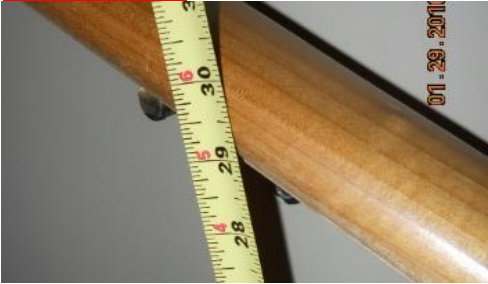
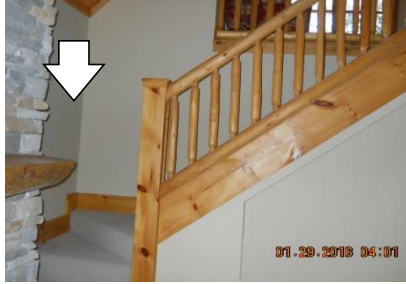
have less than that. Implication: not having handrail at an ergonomically comfortable height could result in someone tripping & falling and not being able to catch themselves.

Handrails are the part of most stairs that people can grab to help prevent tripping while navigating a stair.

Repair/Replace Recommend having State licensed Architect prepare corrective detail, then have State licensed General Contractor repair or replace per Architect's detail.

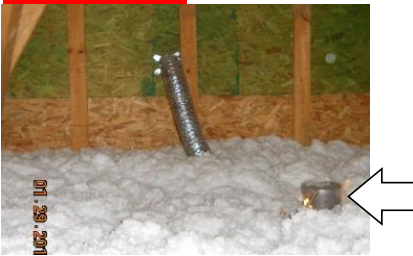
There is insulation here, however it has been moved, or it otherwise is Not continuously protecting the ceiling below as a thermal barrier. Near the eaves, the wind could have blown insulation up and back from the edges of the house.

Repair/Replace Recommend having experienced State-licensed insulation contractor inspect, repair, replace and/or add to as required.

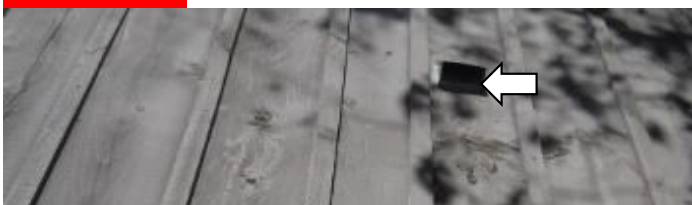
All bathroom exhaust fans should receive ducts to exterior side wall or soffit dampers.

R/R 9.3.2 BATHROOM VENTING: IMPROPER EXHAUST TERMINATIONS: wall caps.

Repair/Replace Recommend having experienced State-licensed contractor inspect, repair and replace as required.
